## DeLorean Owners Association Regional Chapter 41

## Tech Notes

In the last issue I covered the majority of the procedures for destroying the front suspension of your DeLorean. In this issue I will complete the procedures for dismantling the front suspension and cover items to be replaced or serviced prior to re-assembly. Please note that I am only conveying my experiences and will in no way be liable for your dropping your DMC on yourself or having your wheels fall off.

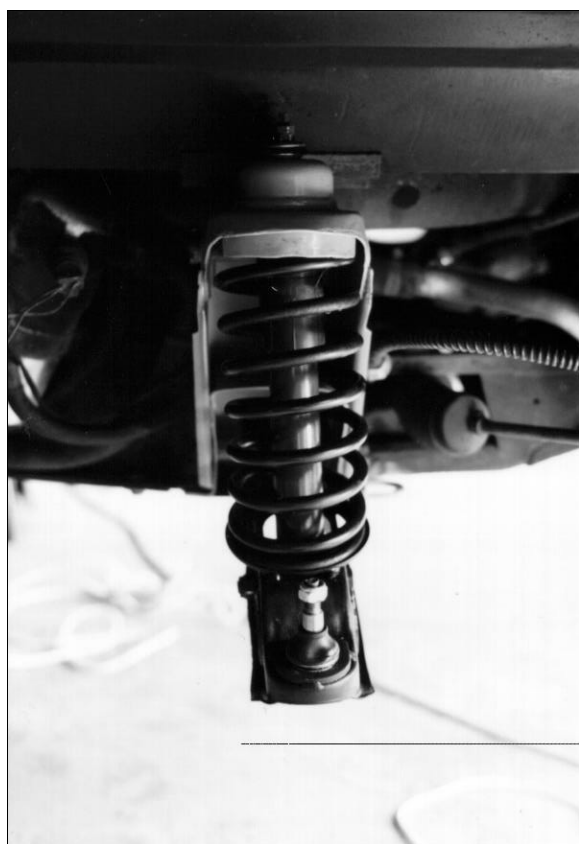
After the procedure outlined in the previous issue, the suspension should appear as in the photo below – only the lower control arm and spring remain of the front suspension assemblies (note that the swaybar has also been removed – see errata at right).

Partially disassembled front suspension.

The next step involves compressing the coil spring with a spring compressor in preparation for removing it. Do not remove the shock absorber until the spring is sufficiently compressed to release the tension from the lower control arm. Doing so will allow the spring to

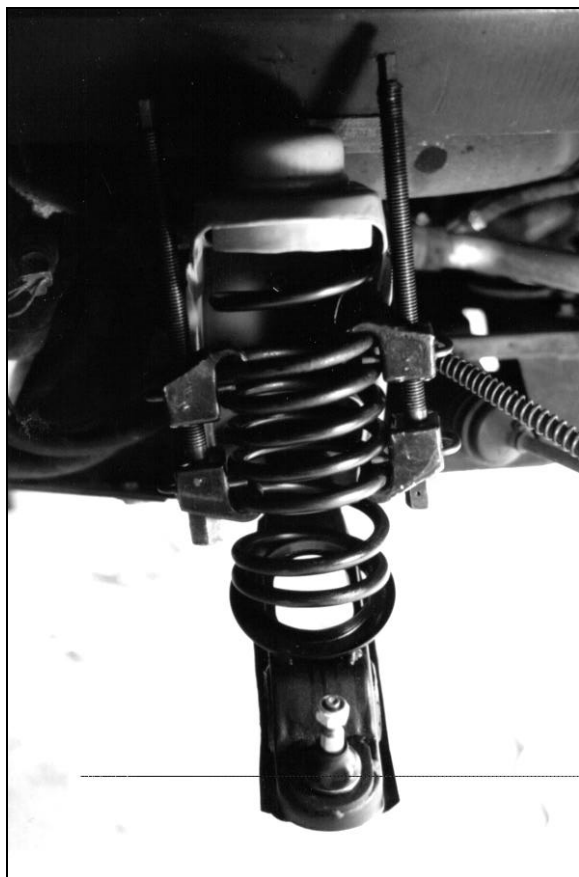
Once the spring is adequately compressed and the compressors are secure, remove the shock absorber. Your front suspension should look as in the figure below.

Compressed spring ready for removal.

Remove the compressed spring (take special care when handling compressed springs) and the rubber seat (46) on which it rests at the top of the suspension tower. If you are having your springs modified, slowly decompress the spring in order to remove the spring compressors.

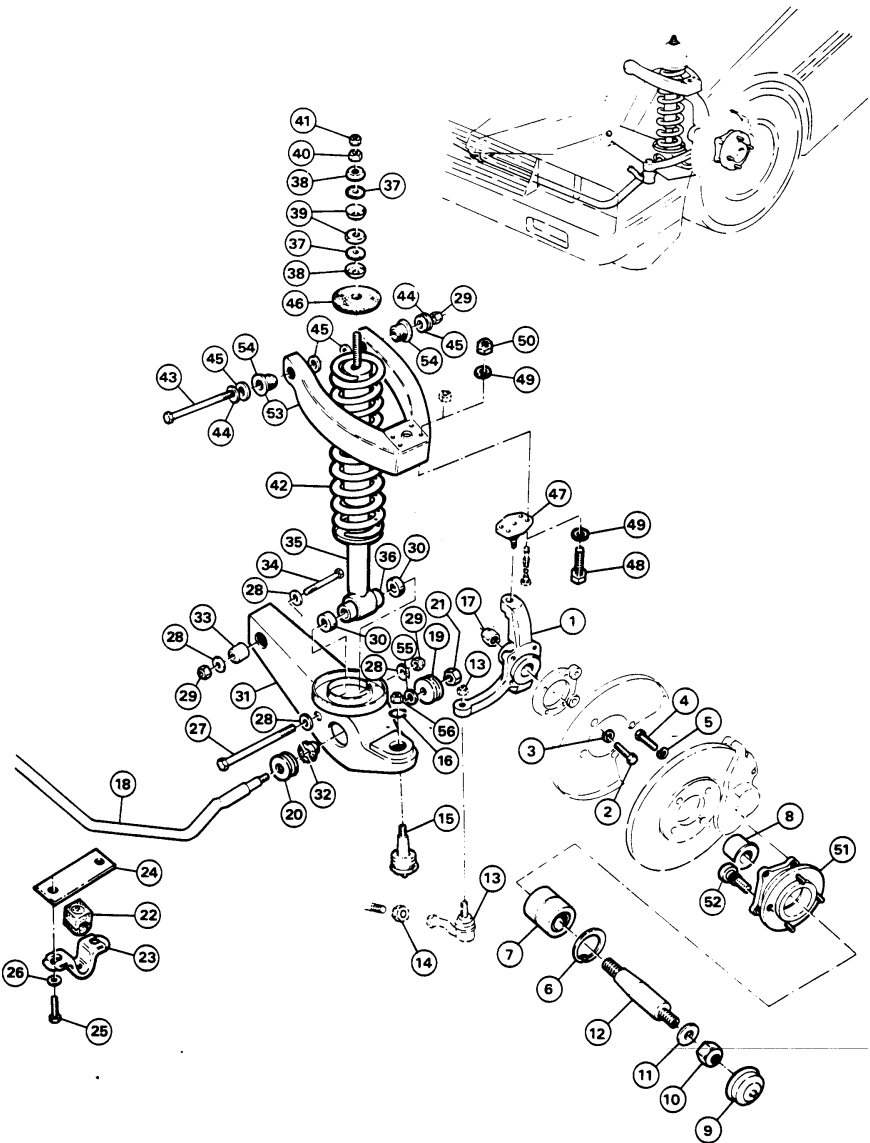
Before installing the hub/disk assembly, you should attach the front sway bar, since it is easier to get to this area before the disk is installed. Install the hub/disk assembly (with new bearings) last before installing the brake caliper. Ensure that all the suspension parts are torqued to specification (torque settings will appear in the next issue)
